POST BROOK DAM

PHASE I INSPECTION REPORT

NATIONAL DAM SAFETY PROGRAM

NJ 00220

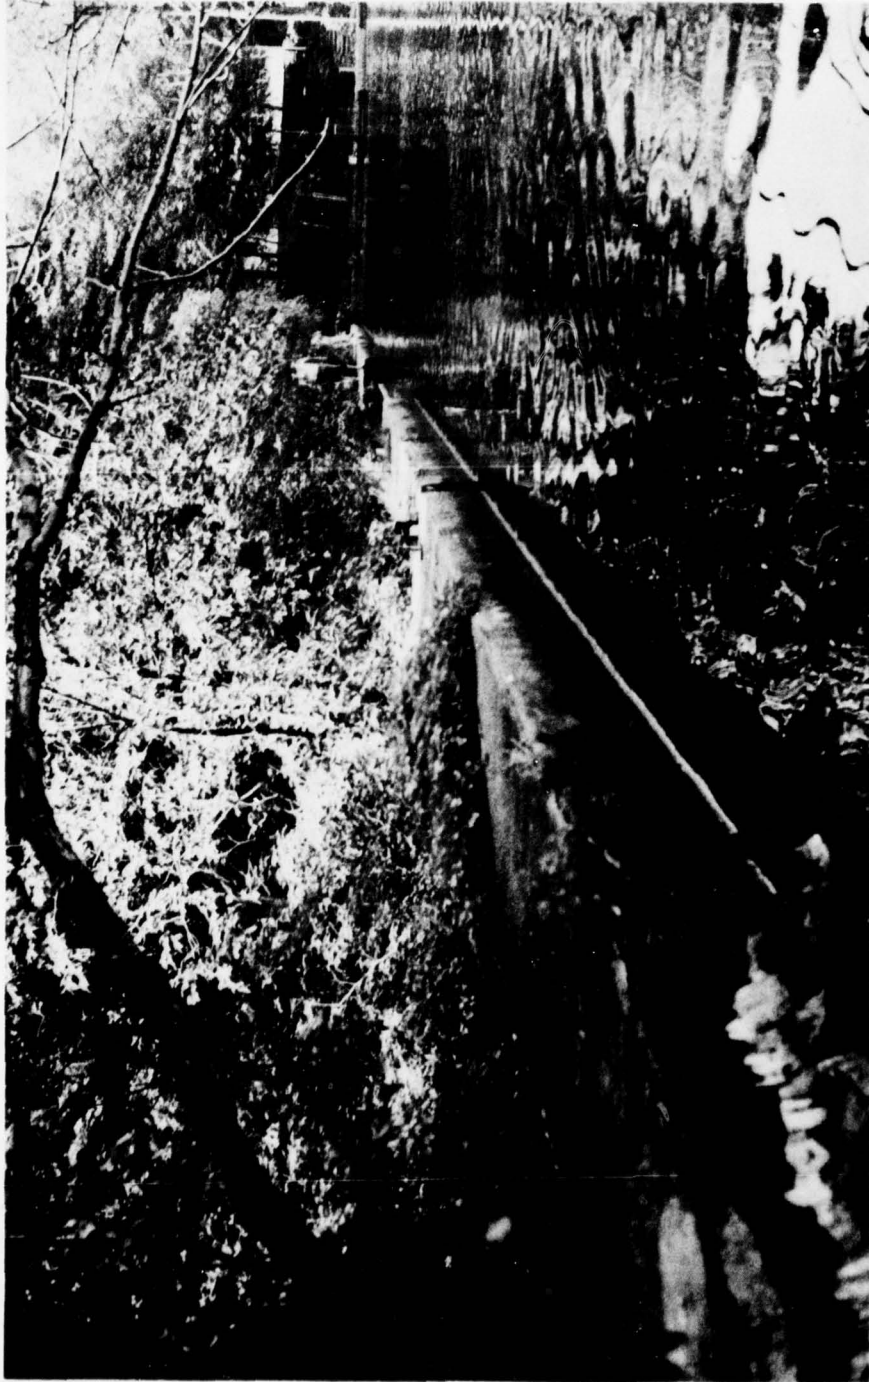
View of dam, outlet notch and spillway from left abutment.

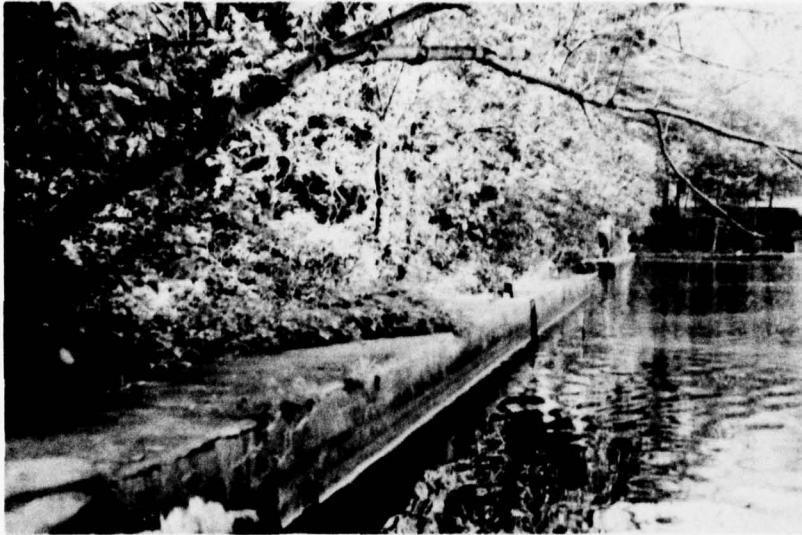
Photo 1 - View of dam, outlet notch and spillway from left abutment.

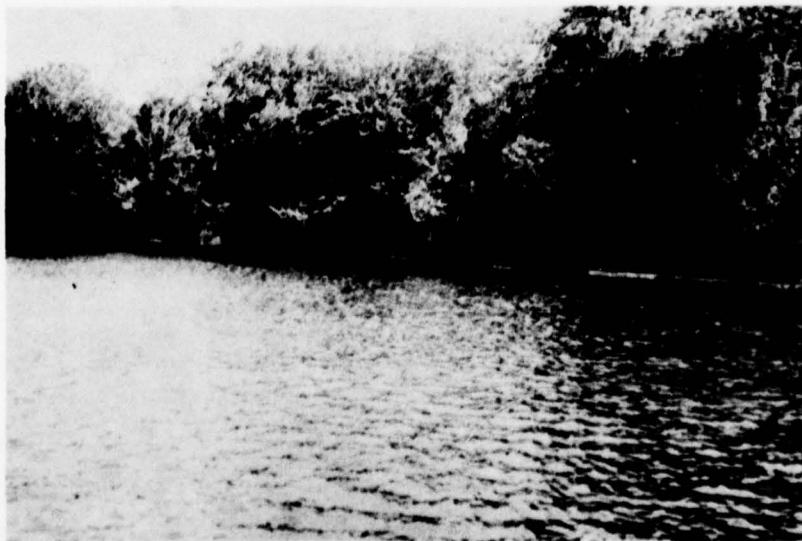
Photo 2 - View of dam from upstream right shoreline.

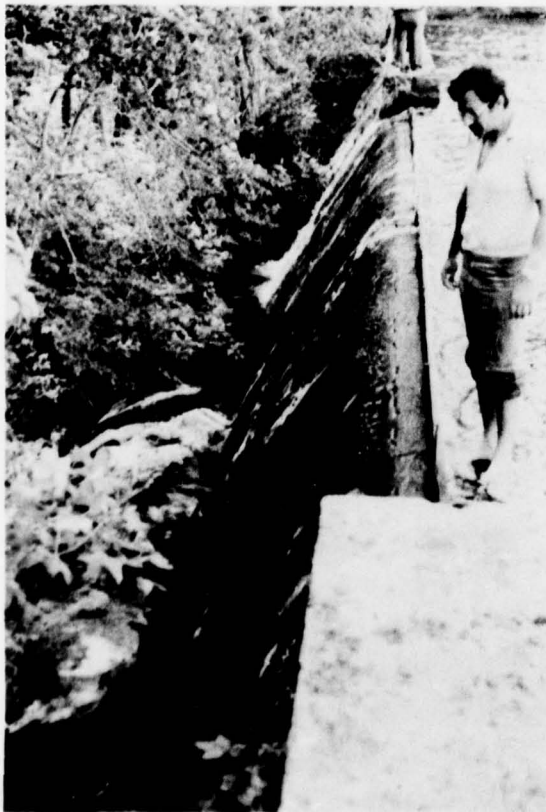
Photo 4 - Spillway crest.

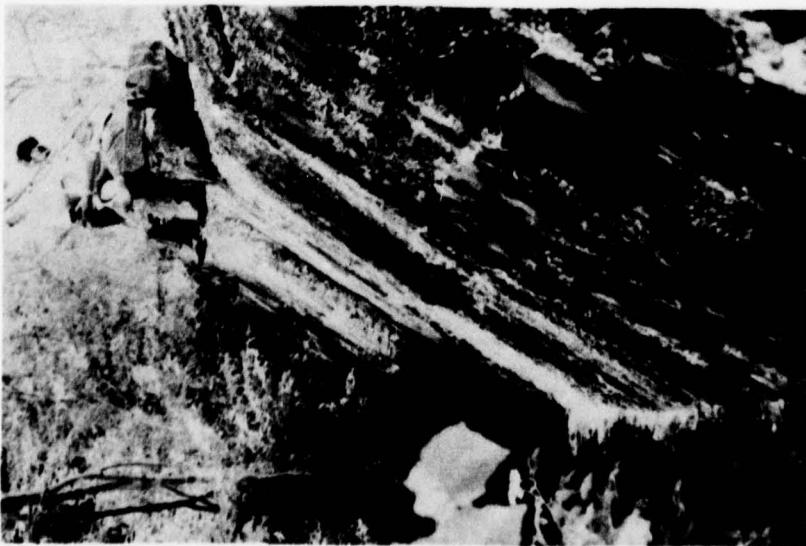
Photo 5 - Downstream face of spillway.

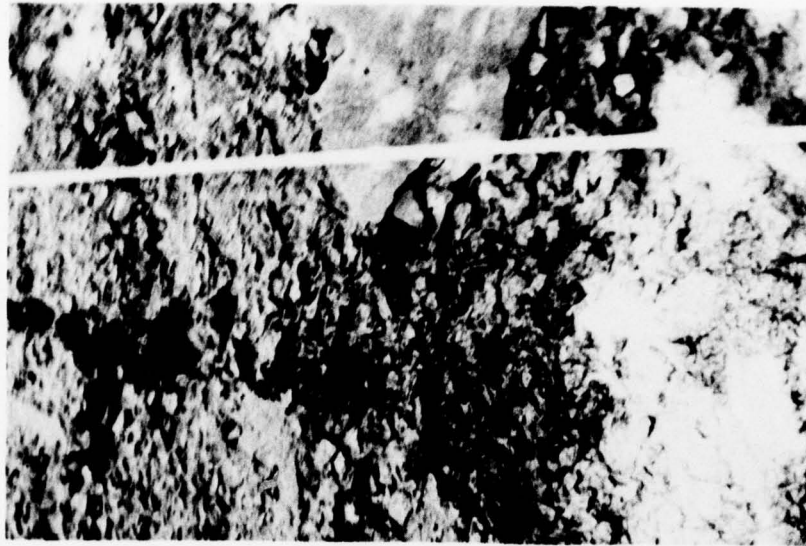
Moderate concrete spalling has occurred on the downstream face of the dam. Considerable spalling has occurred in the mortar cap placed on the crest. Severe spalling has occurred just above a rock contact at the left end of the dam on the downstream side. Several cracks were observed at through joints, however, the concrete appeared to be strong and sound.

Photo 6 - Concrete deterioration and spalling in downstream face of spillway at joint.

Areas of deteriorated, spalled or seriously cracked concrete should be repaired annually to prevent progressive damage.

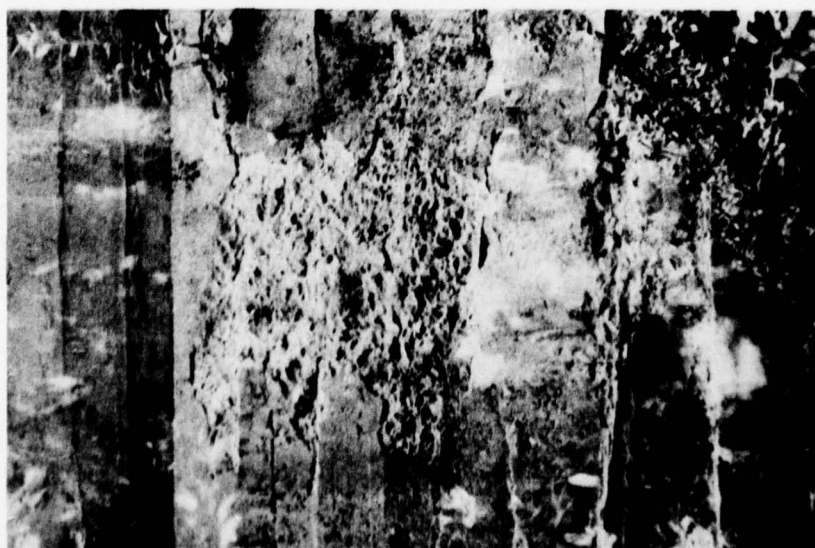
The downstream surface is moderately spalled. Light spalling could be seen on visible portions of the upstream surface. A vertical construction joint, or possible through crack, was observed, however, it was not leaking at the time of inspection.

Photo 7 - Typical spalling on downstream face of dam.

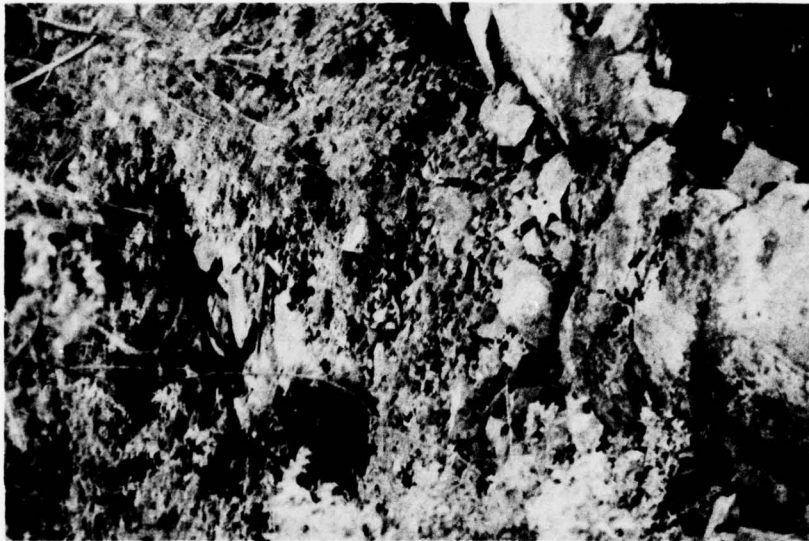
Photo 10 - Discharge channel looking downstream from left of spillway.

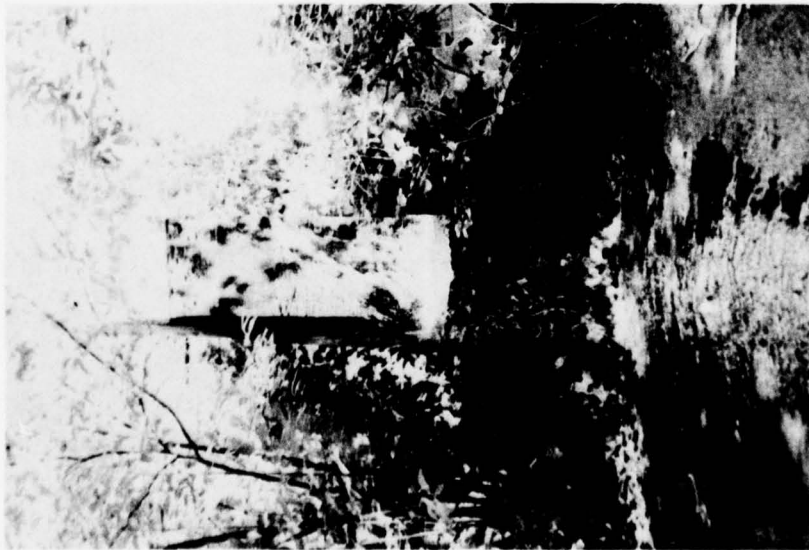
Most horizontal construction joints show evidence of past leakage with the presence of leaching deposits, however, virtually all joints were dry at the time of the inspection. Considerable leakage was occurring from the stoplogs in the sluice. The leakage was estimated at about 20 g.p.m. at the time of inspection. A seep was observed approximately 50 to 75 feet downstream of the dam about midway between the spillway and right abutment. Estimated seepage was about 2 g.p.m. and appeared to be free of fine soil grains.

Photo 9 - View of downstream showing low level outlet notch and stoplogs.

Replace deteriorated stoplogs presently in the sluice.

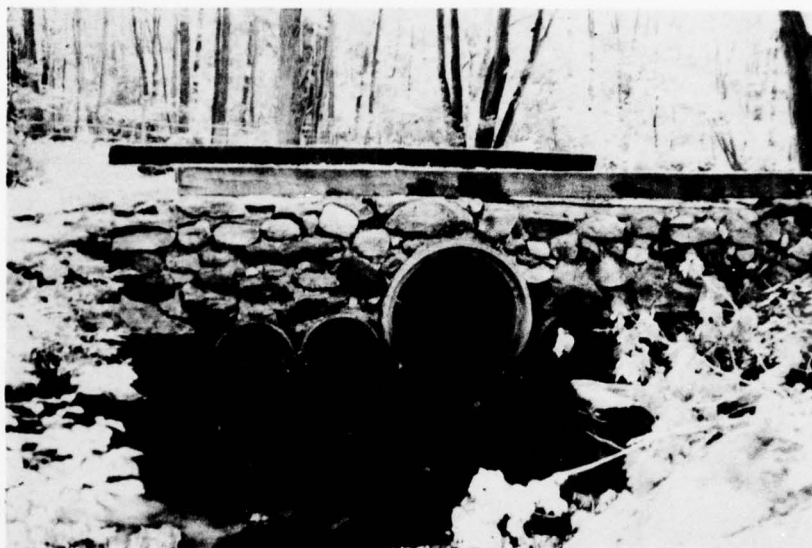
Photo 11 - Multiple culverts under private road downstream of dam.

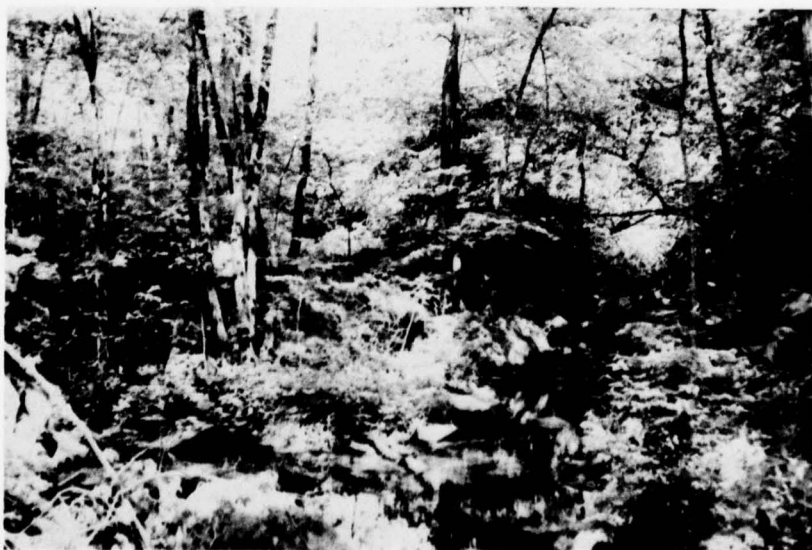
Photo 12 - View looking upstream at dam from culverts.

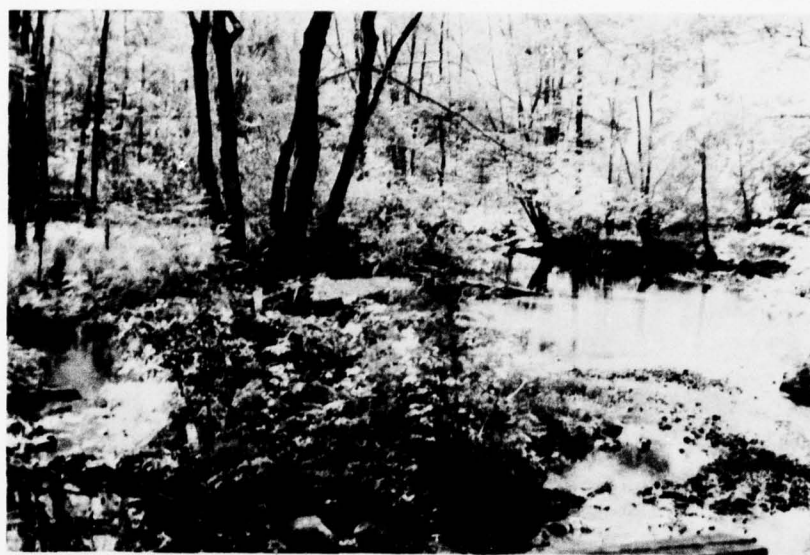
Photo 13 - View looking downstream from culverts.

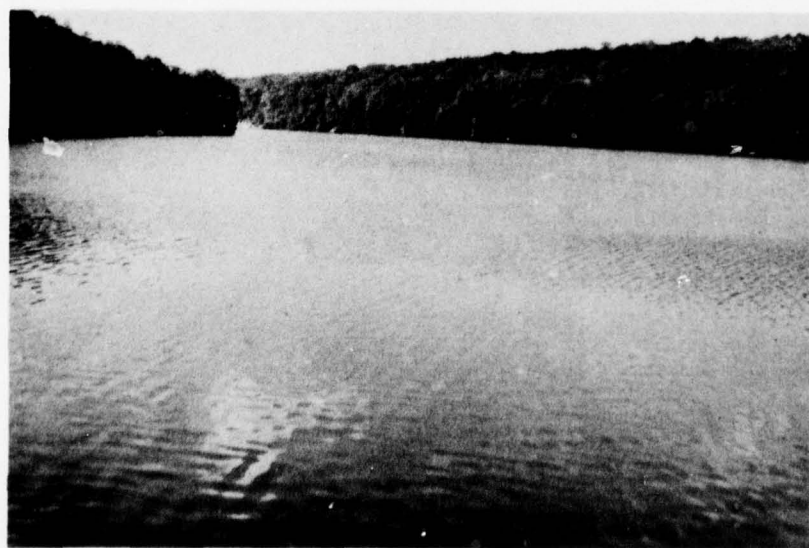
Photo 14 - View of Lake Iosco and shorelines.
